## The Use of Benthic Barriers to Suppress *Hydrilla verticillata* in the Connecticut River

2021-2022 Report

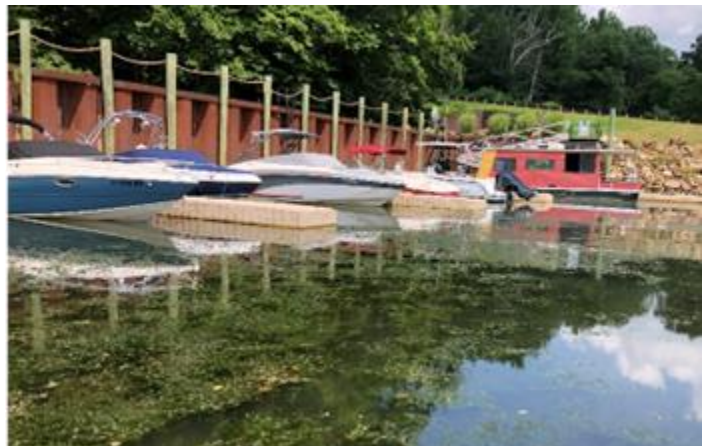
Figure 1. Hydrilla in St. Clements Marina, Portland CT.

neurotoxins that have caused deaths of bald eagles in the southern US (Breinlinger et al. 2021). In recent years, large acreages of dense hydrilla have interfered with boaters, anglers and those who come to recreate on the Connecticut River. Marinas and municipalities have reported that they can no longer access boat slips and docks due to the severity of the infestations (Figure 1).

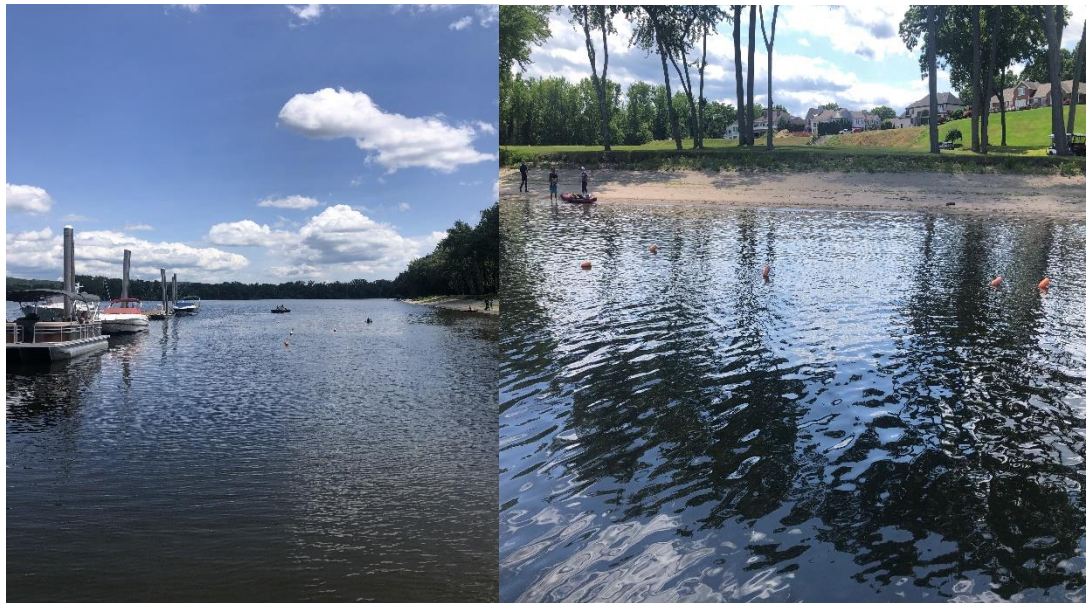
Figures 3 and 4. River Highlands site in Cromwell, CT during benthic barrier installation, 2022.

Before starting the project, we completed a Natural Diversity Data Base application to determine if sensitive or threatened species would be impacted by the project. Through that process, we learned that the Connecticut River at River Highlands is home to freshwater mussels. Before we could put down the benthic barriers, we needed to relocate any mussels in the project site to a safe location (Figure 4).

We began by having a scuba diver assess the project site and relocate any freshwater mussels to a safe location. We then installed four 10' x 20' and four 10' x 30' barriers (Lake Bottom Blanket Co. Wayne, NJ). The barriers were prepared by inserting ½ inch rebar into the benthic mat sleeves positioned at 5-foot increments to weigh down the barriers. On June 15, 2022, CRC and CAES worked together to install the barriers working from docks and a boat in a line approximately 30 feet inside a dock and 50 feet from shore (Figure 3). Adjacent areas known to grow hydrilla served as controls. Barriers remained in the river for four weeks and then were removed on August 13, 2022.
